# Manhole Inspection Summary

Manhole # S51O\_\_026MH

Insp Date: **2/26/09 11:47 AM**

**Location** Address: **2815 odonnell st**

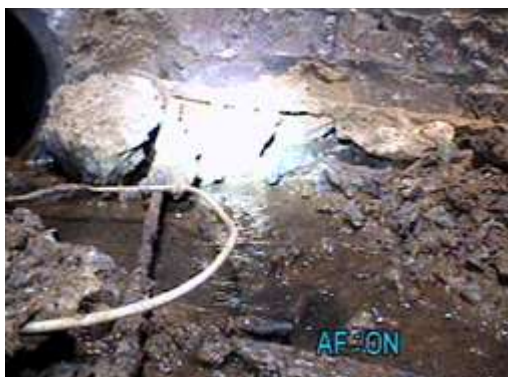
Defect 3

Condition: ☐ Sound ☐ Cracked ☐ Root Intrusion ☐ Deteriorated ☐ Leaks ☒ **Debris**

channel debris

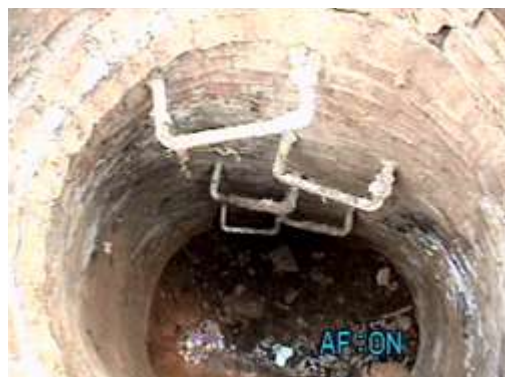
Defect 2

Condition: ☐ Sound ☐ Cracked ☐ Root Intrusion ☐ Loose Brick ☒ **Deteriorated**

Count: **5** Missing: **0** ☒ **Corroded**

deteriorated corbel, cor. steps

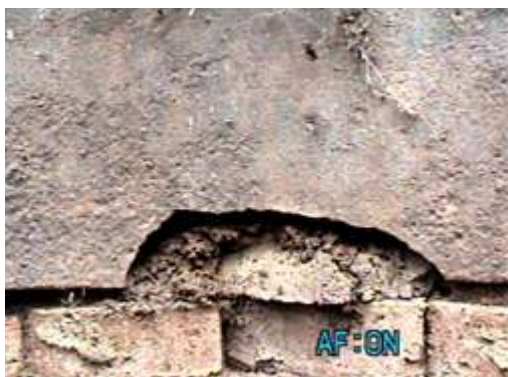
Defect 1

Condition: ☐ Sound ☒ **Cracked** ☐ Leaks

cracked frame
